Final Technical Report
TNW 2008-X
TransNow Budget No. 61-4026 and 61-5916
Agreement XXXXX, Task X
De-Bonding Cracking

**De-Bonding of Hot Mix Asphalt Pavements in Washington State:
An Initial Investigation**

September 2008

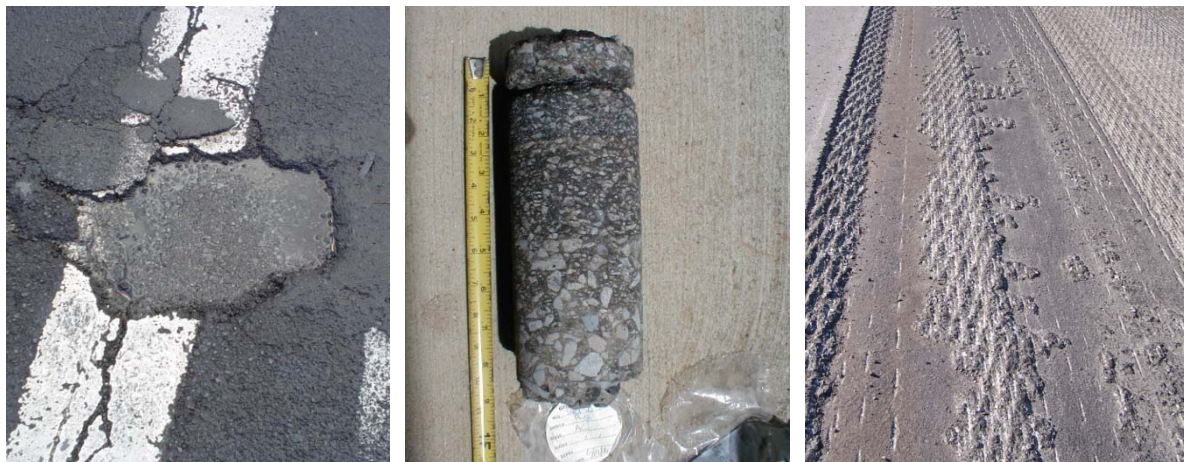
Figure 1: Three types of evidence for de-bonding: shallow potholes (left), detached cores (middle) and loosely attached pavement after milling (right).

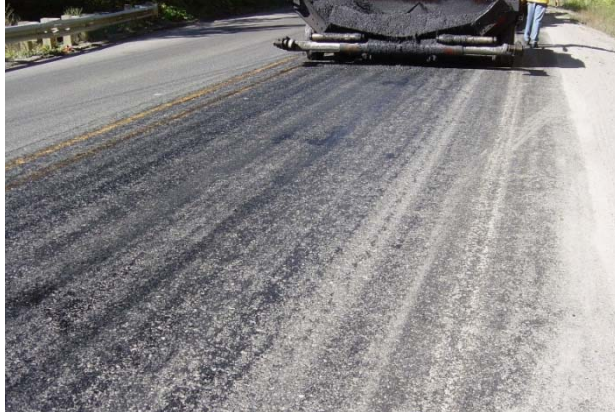
Spotty coverage SR 12

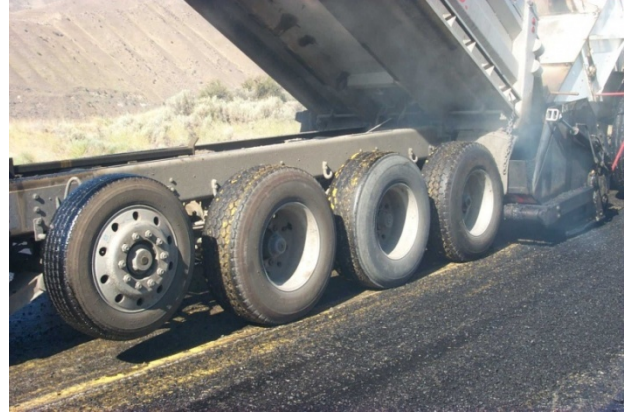
Tack pick-up on SR 2/97

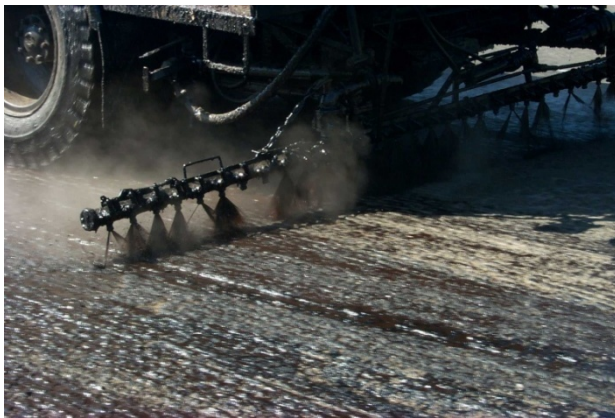
Clogged nozzles on SR 500

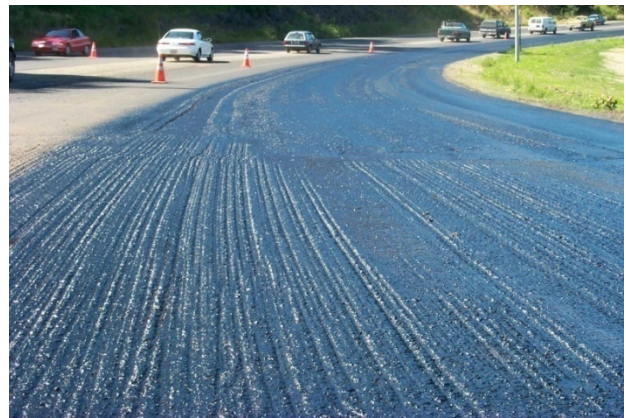
Good coverage on SR 101

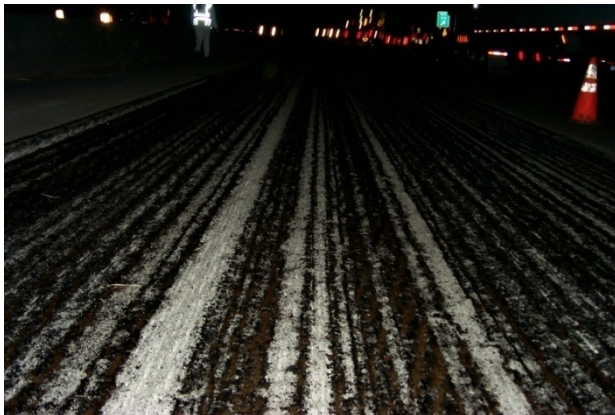
Streaky coverage on SR 5

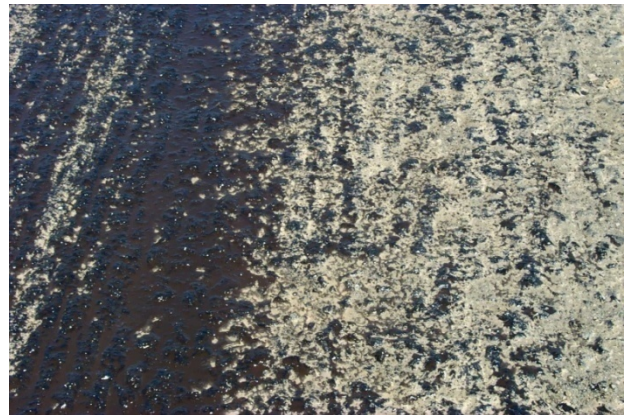
Spotty coverage on SR 500

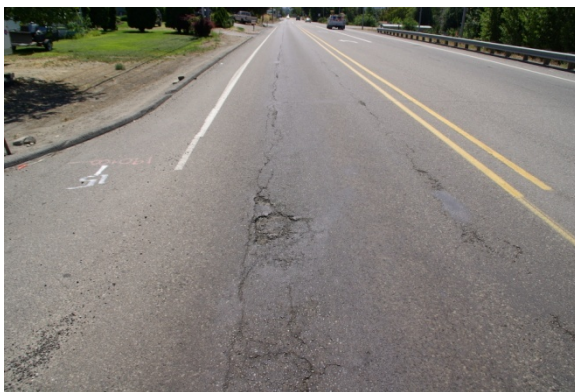
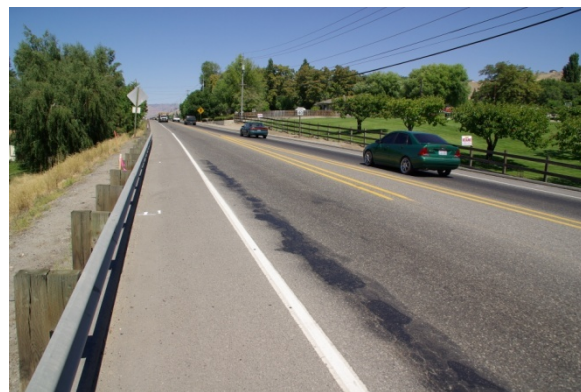
FIGURE 10 Typical views of SR 28 before the project showing substantial wheelpath cracking and flushing.

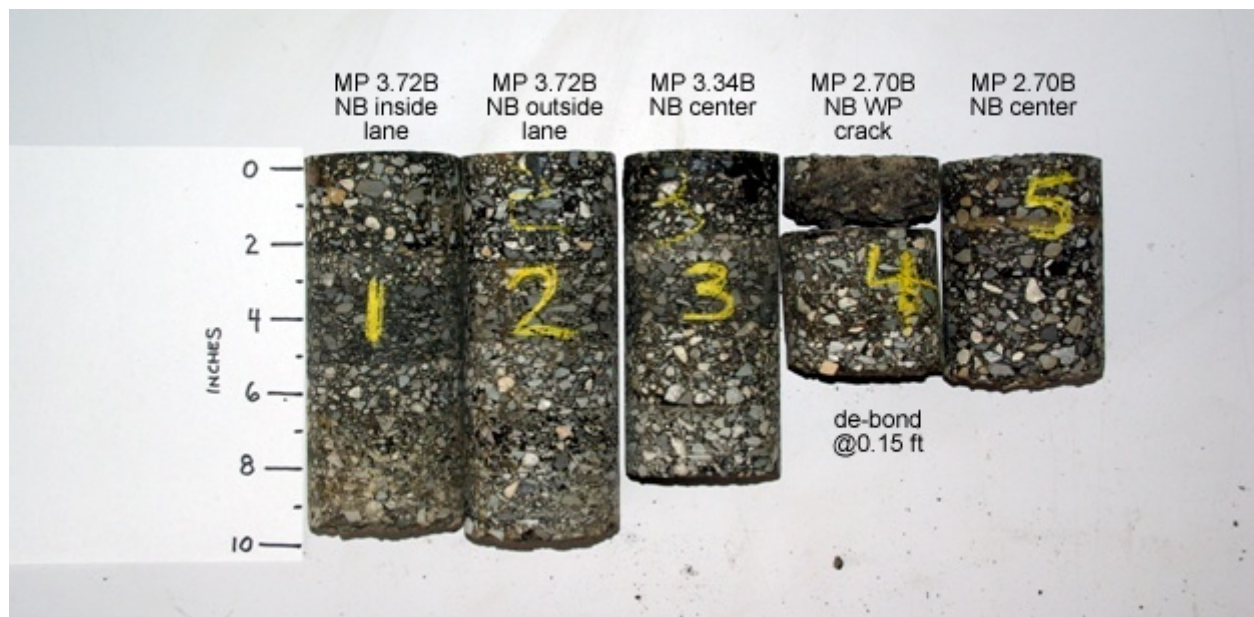
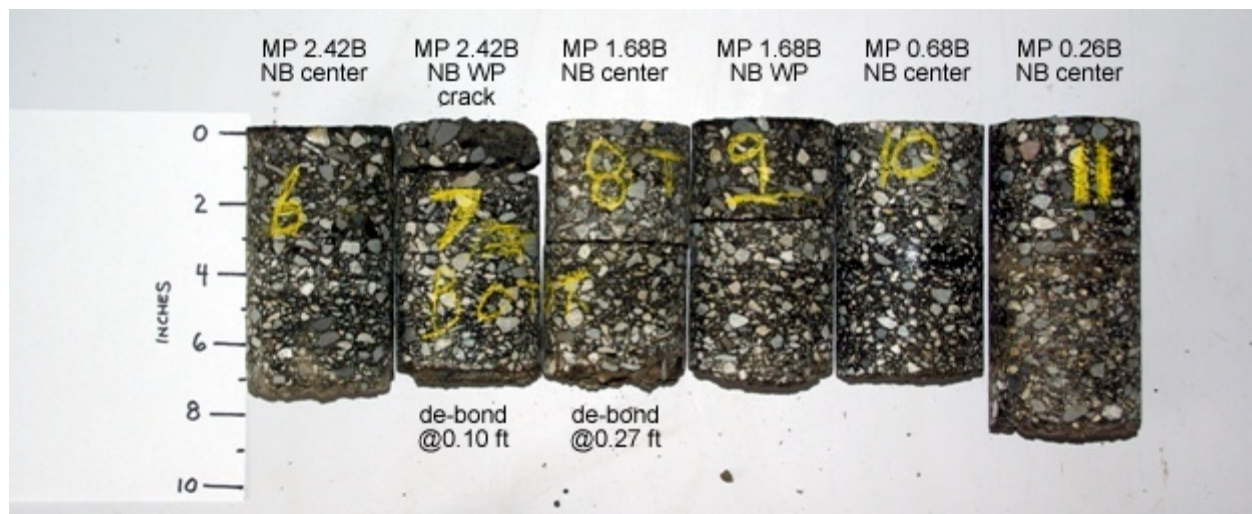
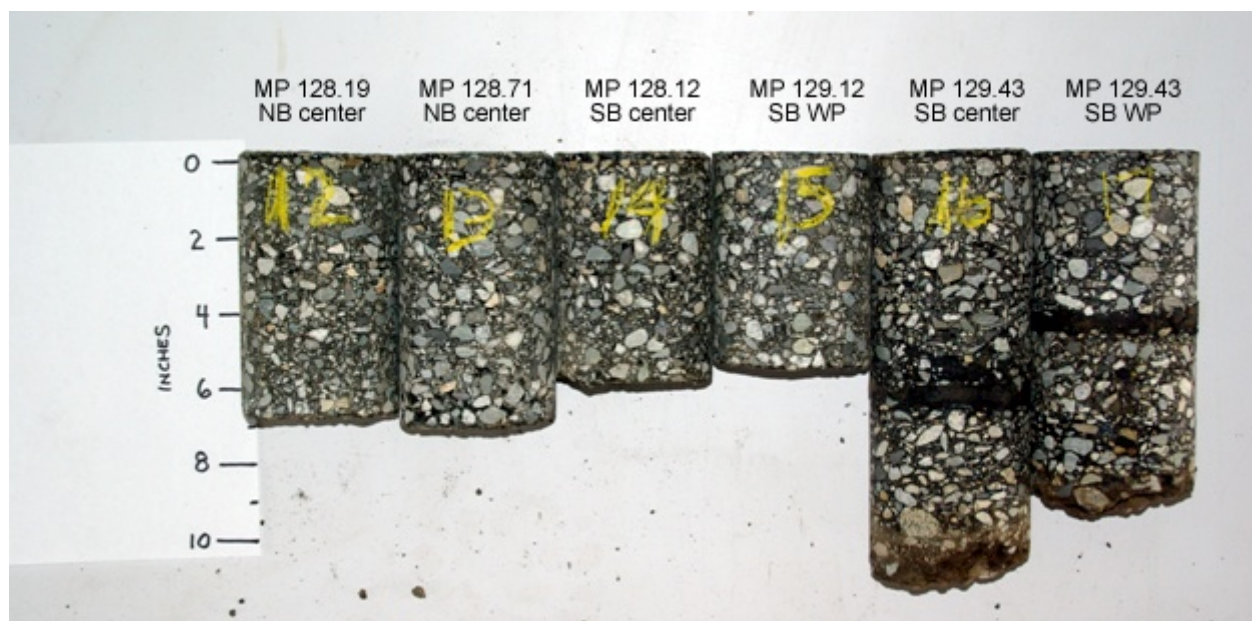
FIGURE 12: Cores from SR 28 from MP 2.70B to 3.72B. WP=wheelpath, NB=northbound, SB=southbound

FIGURE 13: Cores from SR 28 from MP 0.26B to 2.42B. WP=wheelpath, NB=northbound, SB=southbound

FIGURE 14: Cores from SR 2/97. WP=wheelpath, NB=northbound, SB=southbound

These cores tend to show that de-bonding was only occurring in areas of distress (i.e., the cracked wheelpath areas). This might suggest that bonding was adequate during construction and perhaps infiltration of water through the cracks caused the observed de-bonding.

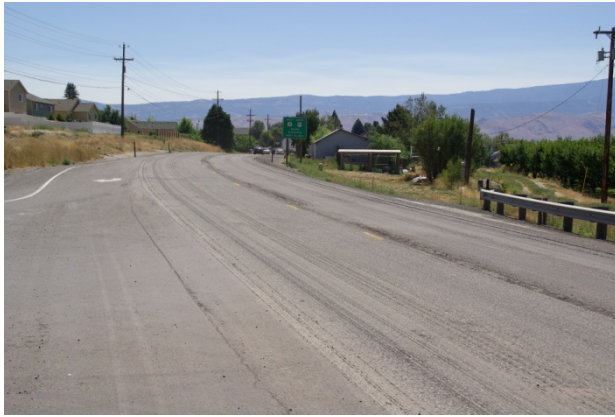
SR 2/97 Milling. Milled surfaces observed on 5 August 2008 on SR 2/97 showed generally good removal of this layer with some localized areas of de-bonding at what appeared to be the old longitudinal joint (Figures 14 and 15). This might suggest that perhaps infiltration of water through a porous longitudinal joint (there were no joint compaction specifications in 1994) caused the observed de-bonding.

FIGURE 15: Milled surface of SR 2/97.

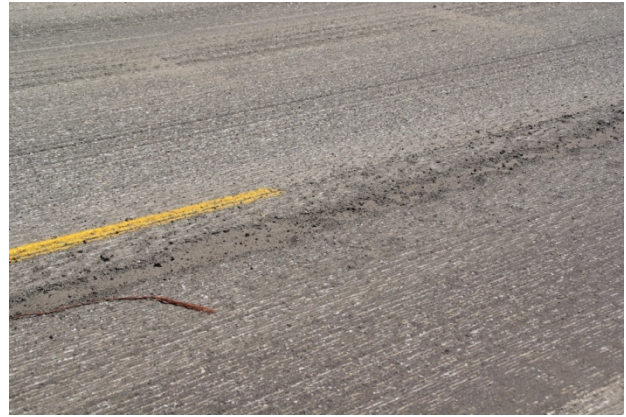
FIGURE 16: Milled longitudinal joint area.

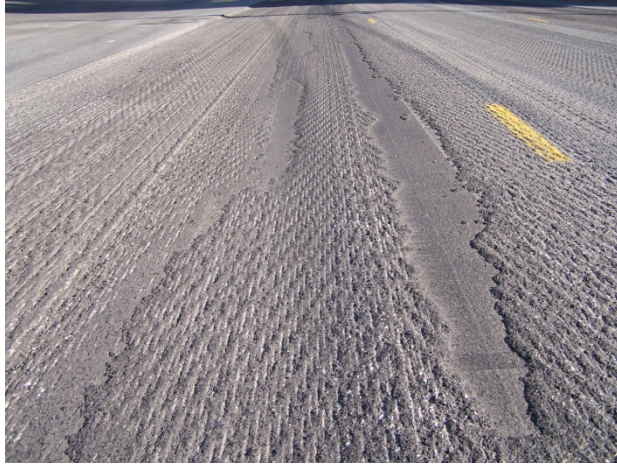
SR 28 Milling. Milled surfaces observed on 6 August 2008 on SR 28 showed generally uneven removal of the last overlay and revealed areas where a fabric that was placed with the last overlay to slow reflective cracking had lifted up and de-bonded from the lower layers (Figures 16 and 17).

FIGURE 17: Milled surface of SR 28.

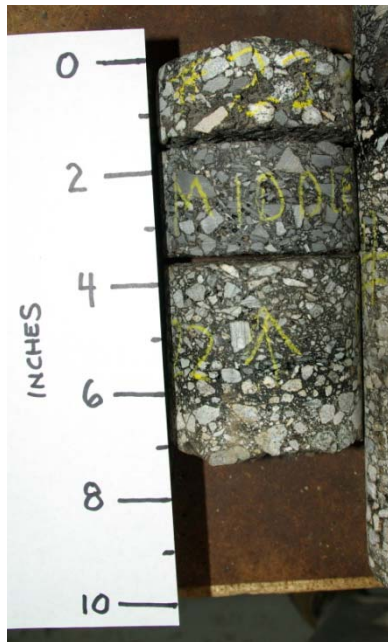
- Poor tack coat application. Some cores (Figure 20) showed clear de-bonding between one or more layers with only limited surface distress.
- Water infiltration. Some cores (Figure 21) showed de-bonding accompanied by major surface distress suggesting that perhaps water infiltration contributed to the de-bonding.

FIGURE 20: Poor tack.

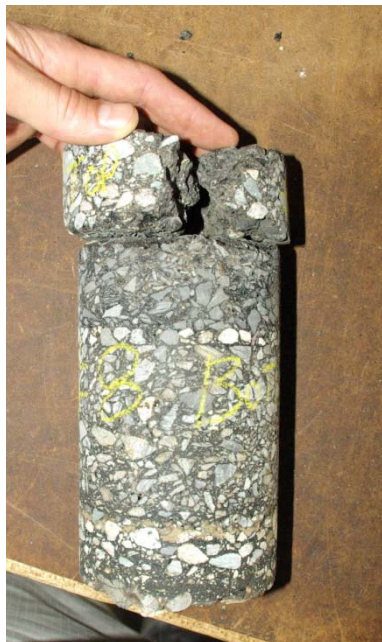
FIGURE 21: Cracked surface.

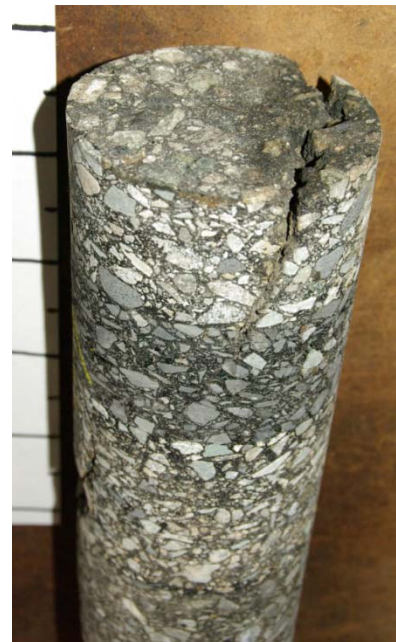
Also, some SR 2 cores exhibited classic signs of top-down cracking (Figure 22). Still other cores, reportedly taken near de-bonded cores exhibited no de-bonding or distress.

FIGURE 22: Top-down crack.

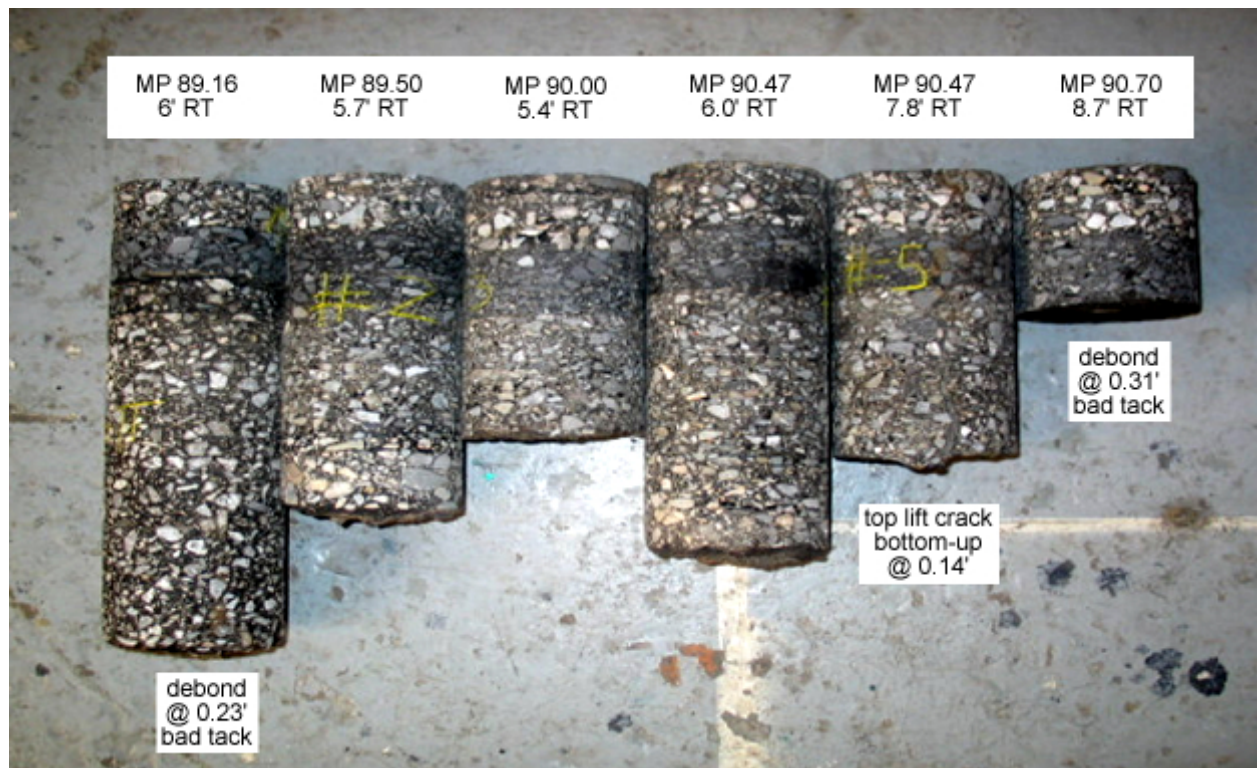
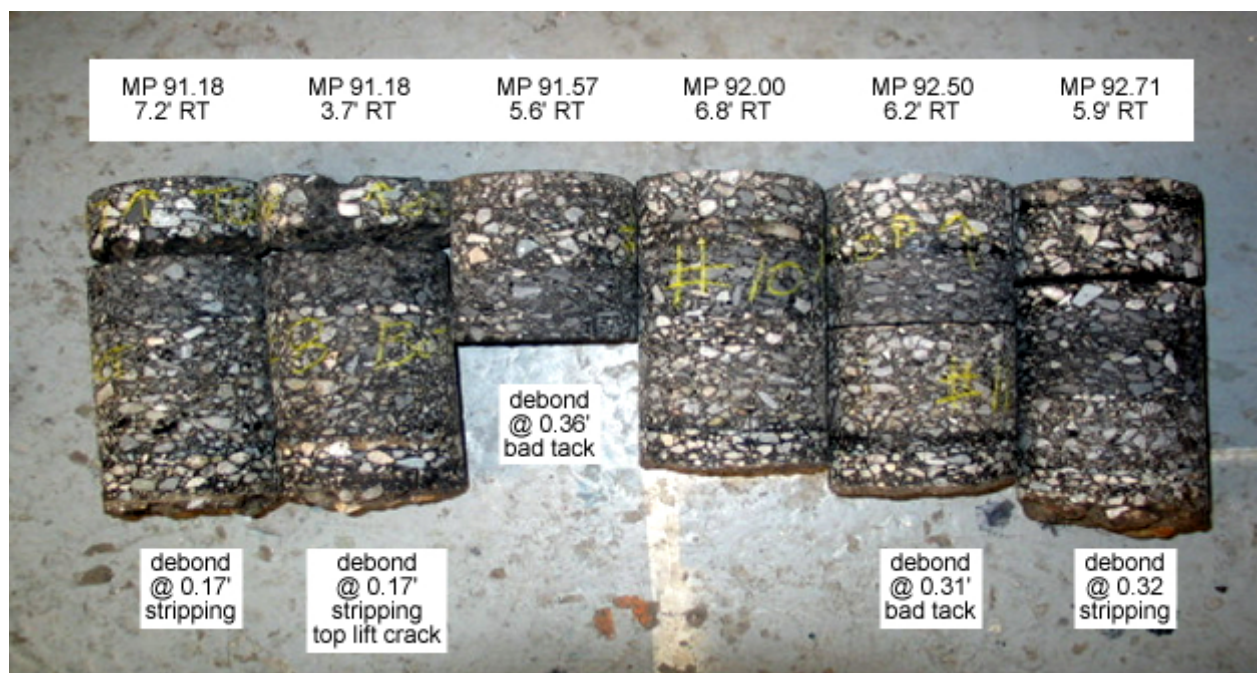
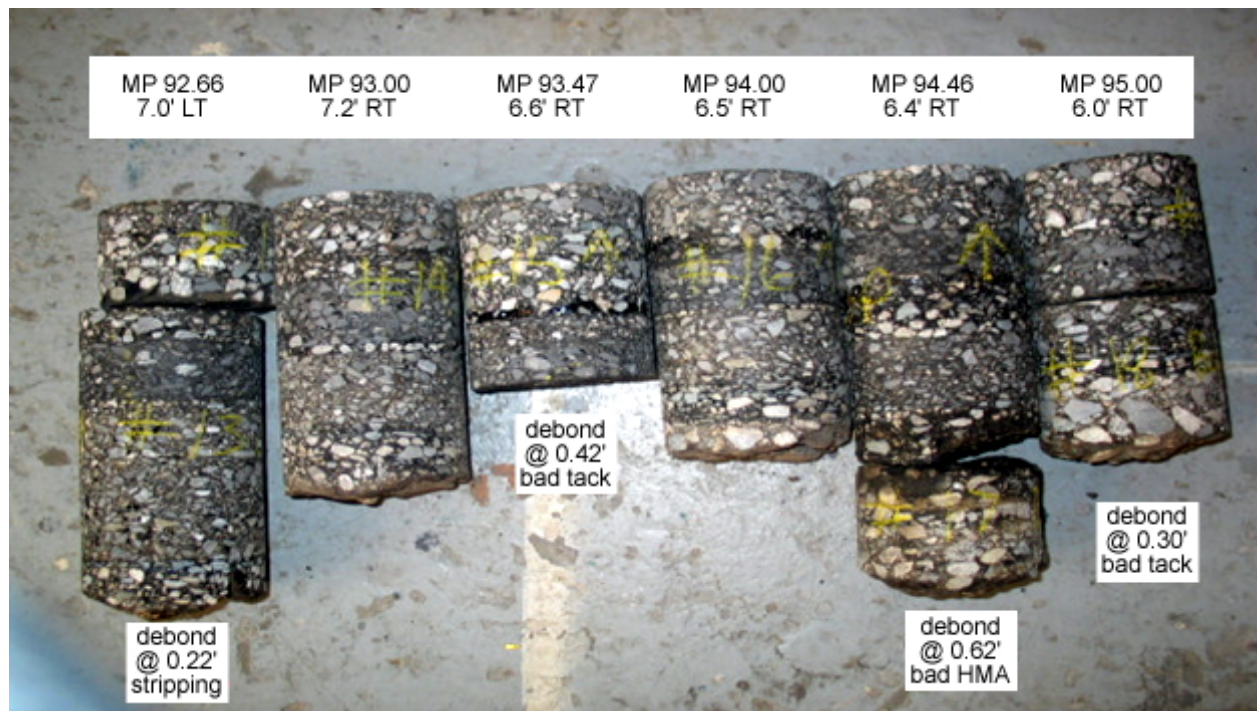
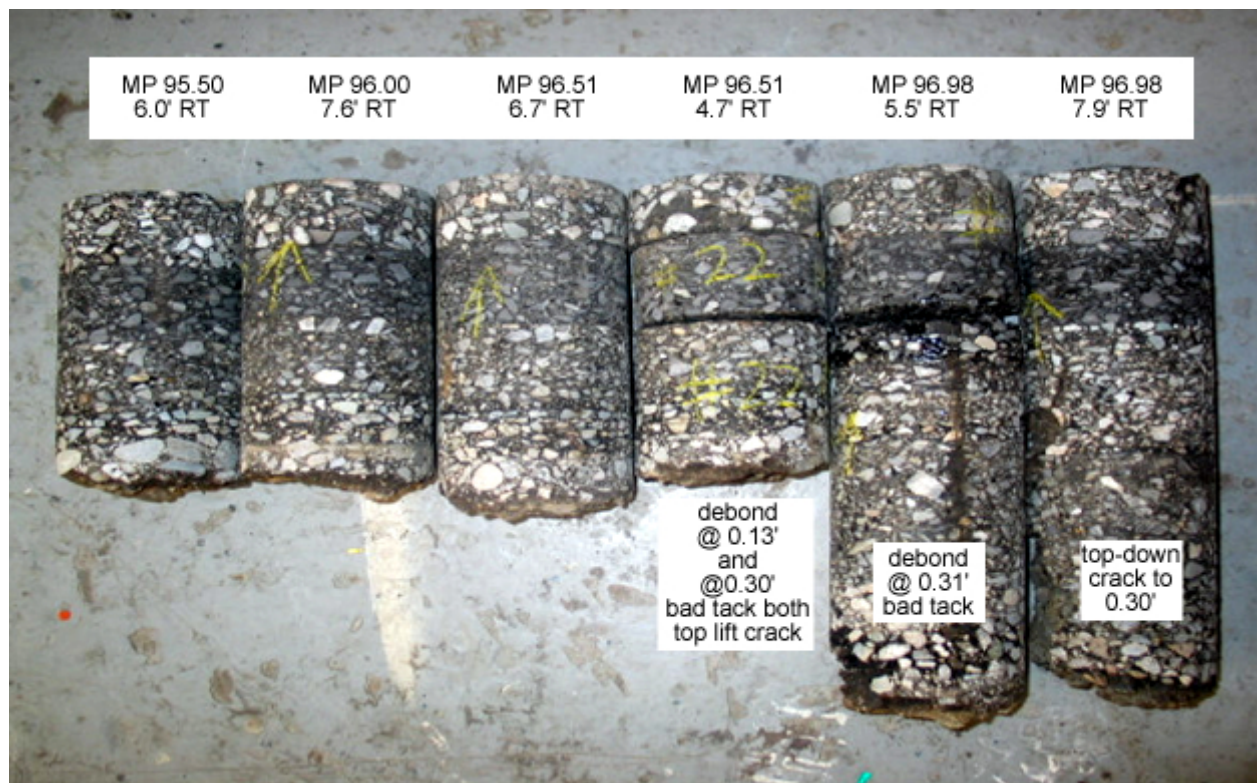
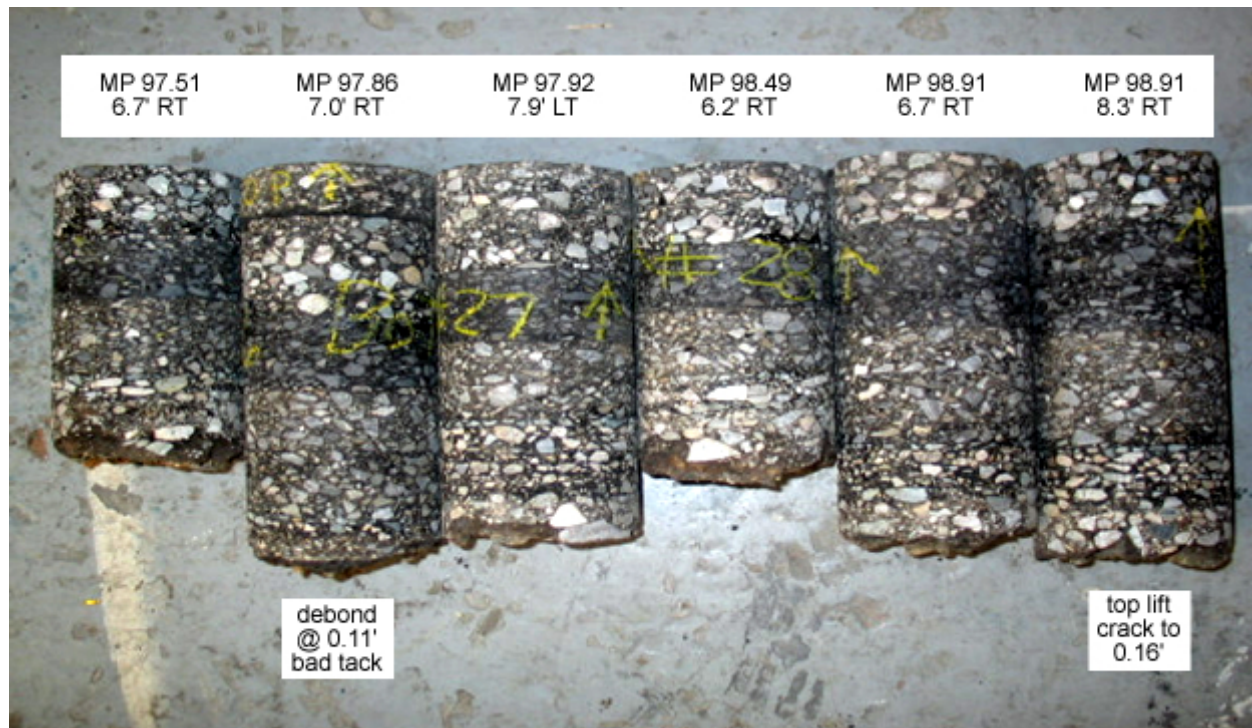
De-bonding below about 0.55 ft is likely separation of upper HMA lifts from lower BST layers and probably does not indicate HMA de-bonding as described in this study. These cores tend to suggest that de-bonding may be widespread with 14 cores de-bonded. Many are not associated with surface cracks suggesting that poor tack coat adhesion rather than water infiltration may be the primary cause. Of note, cracks in the wheelpath cores seem to extend only to the HMA layer interface that shows a lack of bonding in the companion outside-the-wheelpath core (see MP 91.18, 96.98, 98.91).

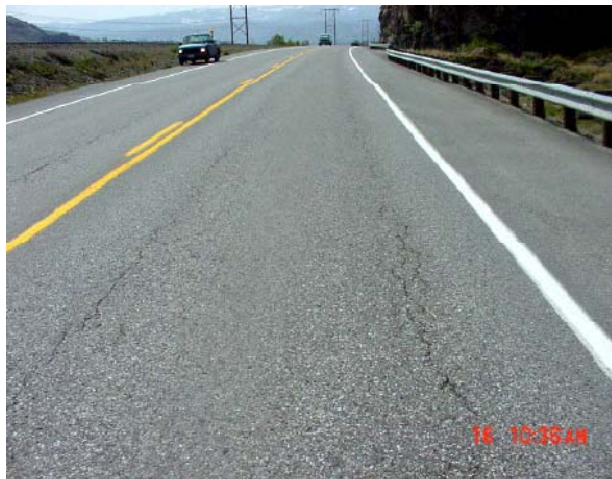
FIGURE 30: Looking south from MP 202.50 showing wheelpath longitudinal cracking.

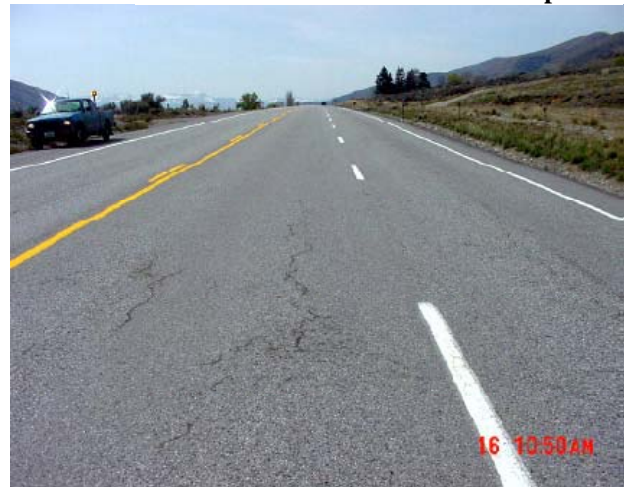
FIGURE 31: Looking south from MP 207.37 showing wheelpath cracking.

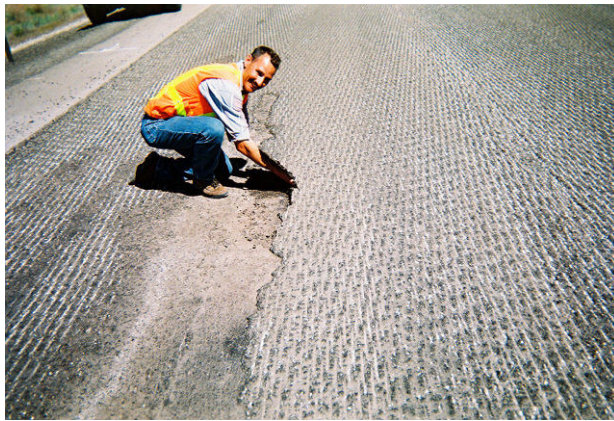
FIGURE 33: Milled surface of SR 97A showing de-bonded area.

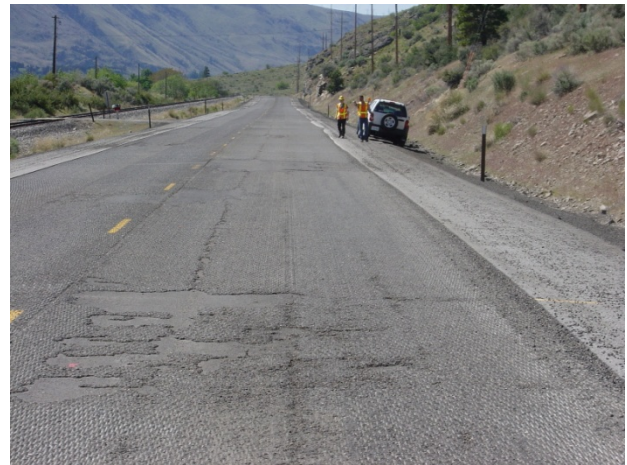
- **Gear box and auger drag streaks.** Streaks of low density HMA can form behind a paver gear box or auger drags (Figure 34) because the auger cannot place enough HMA or places segregated HMA behind these auger attachment points (Figure 35). We speculate that this low density material may have let water infiltrate in surface HMA layer, which contributed to de-bonding.

FIGURE 34: Milled surface of SR 97A showing de-bonded area probably from construction-related temperature differentials and gear box streaking.

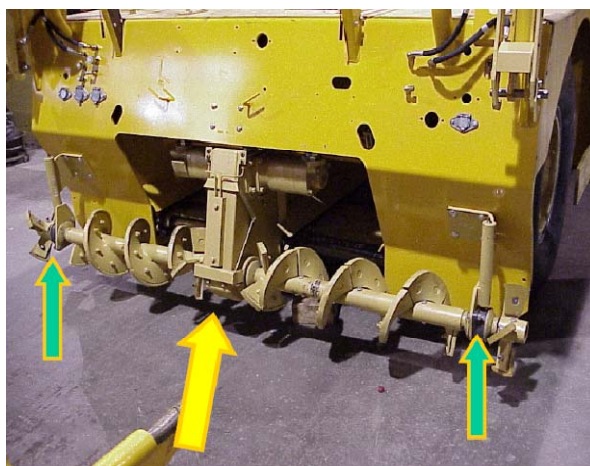
FIGURE 35: The three parallel streaks in Figure 30 were likely caused by the low density HMA areas behind a paver's gear box (yellow arrow) and auger drags (green arrows). This low density is caused because the paver's auger cannot place enough HMA or places HMA that is segregated behind these attachment points.
