Final Technical Report
TNW 2008-X
TransNow Budget No. 61-4026 and 61-5916
Agreement XXXXX, Task X
De-Bonding Cracking

**De-Bonding of Hot Mix Asphalt Pavements in Washington State:
An Initial Investigation**

September 2008

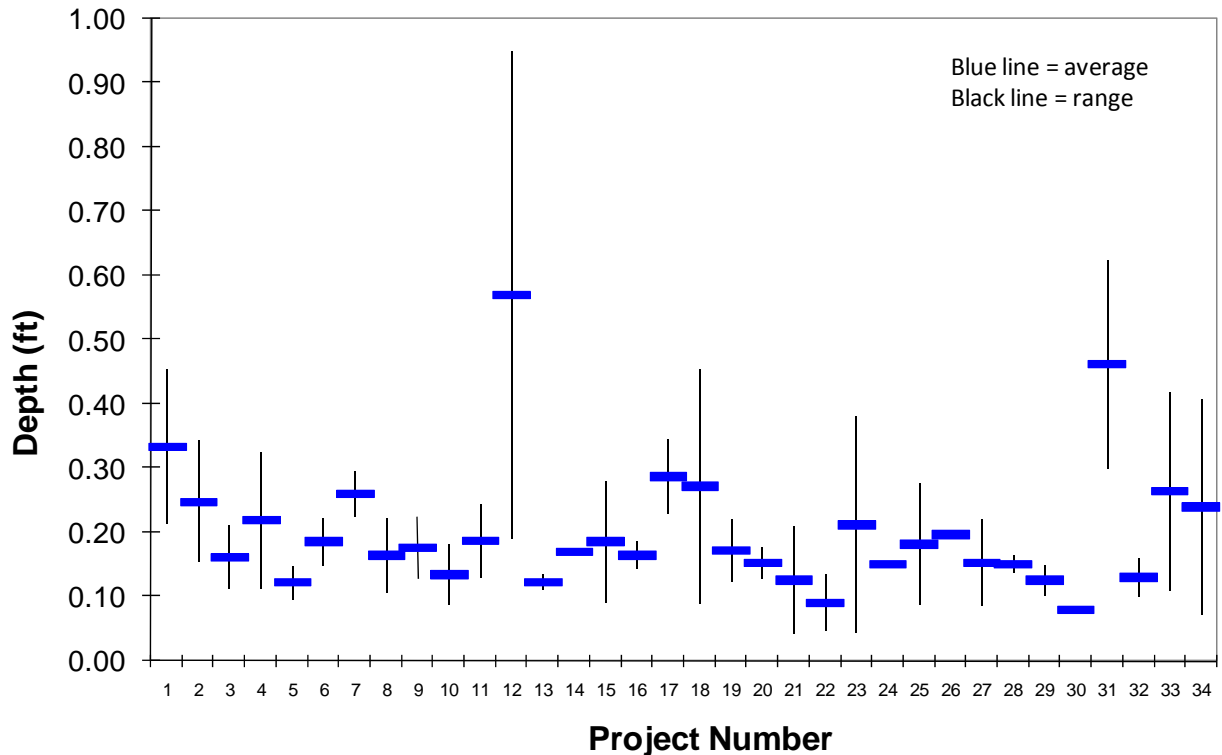
Typical WSDOT overlay thickness is 0.15 ft, which corresponds closely with the average depth to the first de-bonding in those cores with observed de-bonding (Figure 3).

FIGURE 3: Recorded depth to first de-bonding for all de-bonded cores.

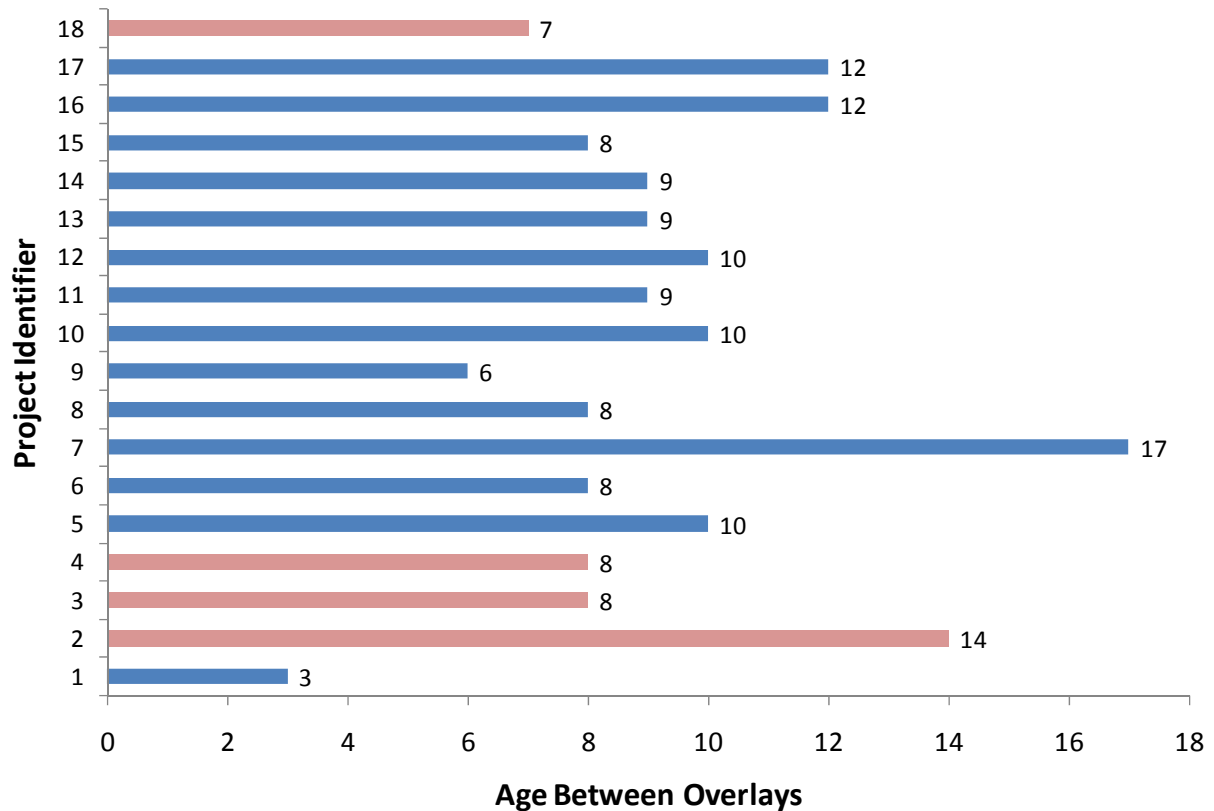
Given that most of the cores were done in preparation for an overlay it is useful to determine the life span of the layer that exhibited de-bonding in the core. Typically, HMA surface layer life ranges from about 14 to 18 years in Western Washington and 8 to 12 years in Eastern Washington. All 18 projects showing de-bonding are located in Eastern Washington (since a vast majority of projects in this core sample are from Eastern Washington or mountain passes – about 85% – this may or may not be significant). Figure 4 shows that most de-bonded cores come from surfaces that tend to last on the short end of the typical 8 to 12 year life range for Eastern Washington projects. This suggests that these projects with de-bonding might deteriorate faster however considering the non-randomness of the samples and lack of other project data this is a weak suggestion at best.

FIGURE 4: Age between the overlay that was de-bonded and the subsequent overlay in preparation for which the coring was done. This gives an idea of how long the de-bonded surface lasted. Red (light) shaded bars represent projects that were not yet overlaid as of 2006.

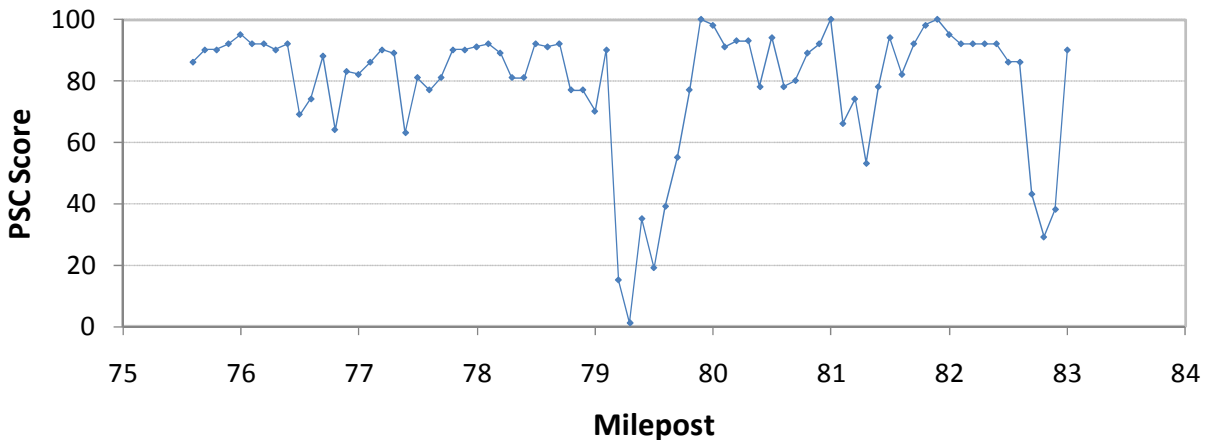
- Even jobs that show significant cracking still have PSC scores that are generally above 80, still quite good. This probably means that cracking has started earlier than average but is not yet advanced enough to severely affect PSC scores.
- Jobs that score below a PSC of 90 generally do so because isolated sections score significantly lower than the average. Project 5841 is typical of this (Figure 7).

FIGURE 8: Project 5841, SR 27 MP 75.66 to 83.10 (paved in 2000 – 6 years old) showing PSC vs. milepost.
Each data point represents the PSC score for one survey unit.

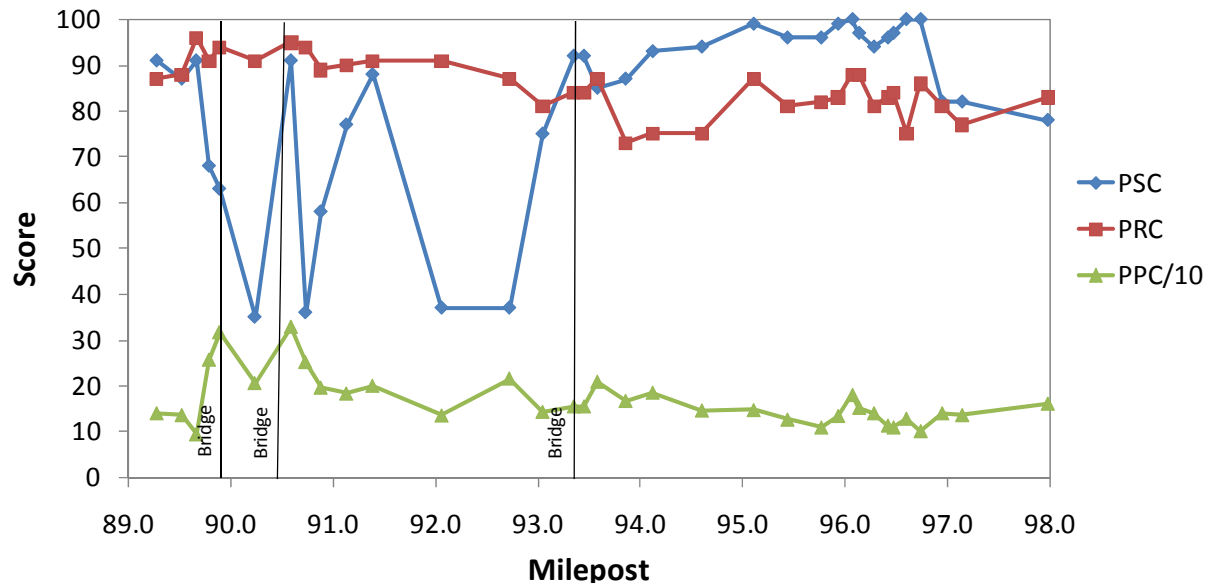
Figure 23 shows that the existing pavement is exhibiting generally low scores for structural condition (cracking).

FIGURE 23: SR 2 pavement condition by milepost. Note the three bridge locations.

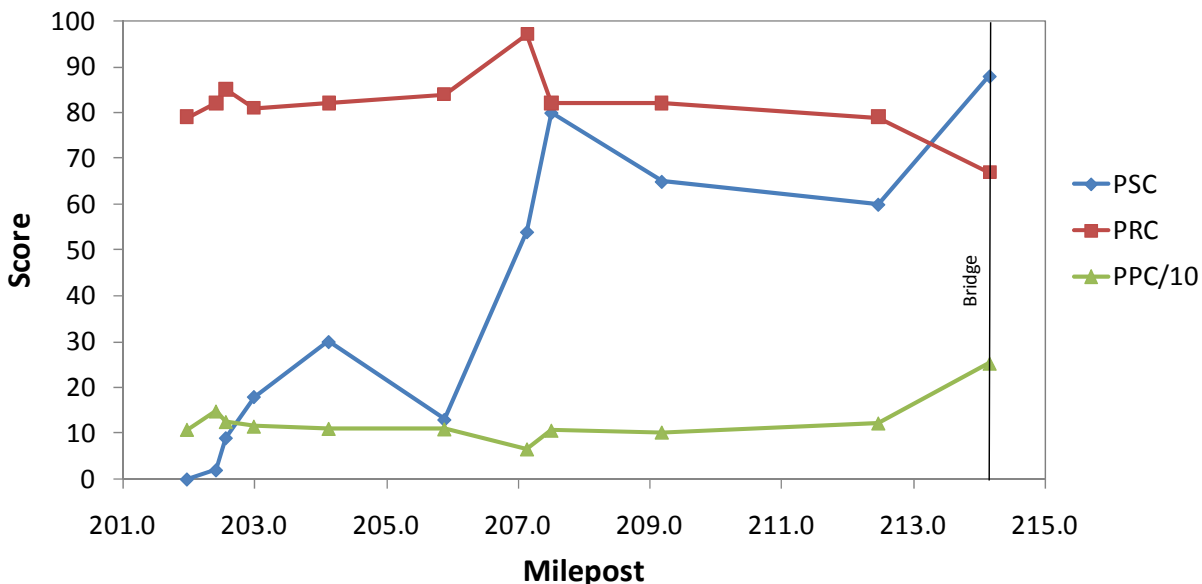
Therefore, scores shown from 2006 data are likely higher than the actual scores in 2008 when the coring was done. Explanations of these condition calculations are contained in Kay et al. (1993). **Figure 32** shows that the existing pavement is exhibiting generally low scores for structural condition (cracking).

FIGURE 32: SR 97A pavement condition by milepost. Note the location of the bridge.
